Cornerstone Home Inspection

1234 School House Road
Yourtown, US 12345

Prepared for: Bob Smith

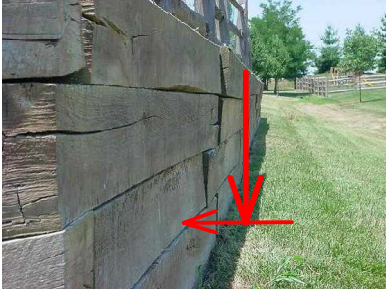
| 8. | <input type="checkbox"/> | <input type="checkbox"/> | <input type="checkbox"/> | <input checked="" type="checkbox"/> | <input type="checkbox"/> | <input type="checkbox"/> | Retaining Walls: Railroad ties The wall is showing signs of movement, but appears to be stable at this time. A qualified contractor is recommended to evaluate and estimate repairs to maintain the wall. |

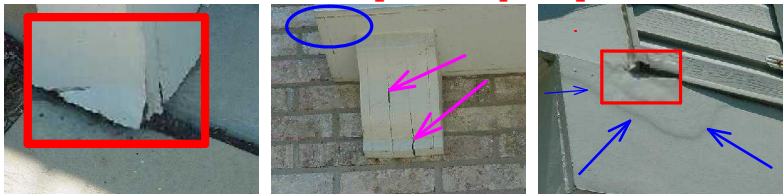
1. Water damage to trim wood at either side of garage door from moisture wicking into the finished particle board. The surface is starting to delaminate. Recommend repair/replacement of the trim boards and silicone seal wood that is in contact with concrete to prevent wicking.

2. The wood window boxes have water damage and will require repair/replacement. The wood has started to separate at the supports and at the corners of the window boxes.

3. The trim board at the southwest corner of the porch has water damage due to water penetration and will require repair/replacement of the wood. The trim board extends out creating a ledge allowing water to collect on the top edge of the board and cause the wood to rot.

Recommend estimate/repairs by a qualified contractor.

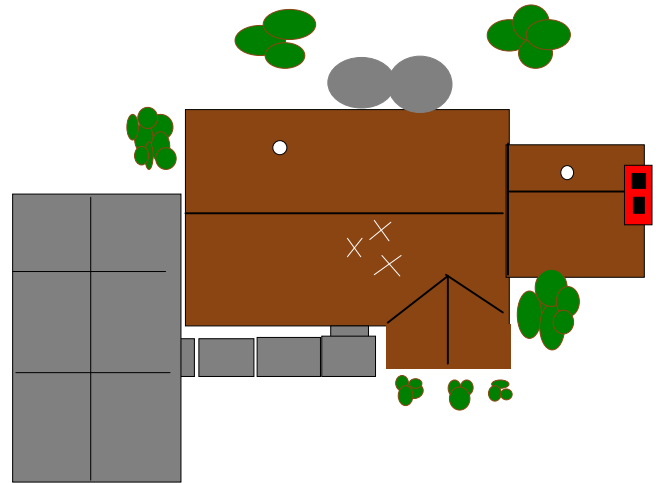
Main Roof Surface

1. Method of Inspection: On the roof
2. Unable to Inspect: 30% Height of the roof
3. Material: Fiberglass shingle Missing roof shingles from wind damage as marked "x" in diagram. Repairs are required.
4. Type: Gable

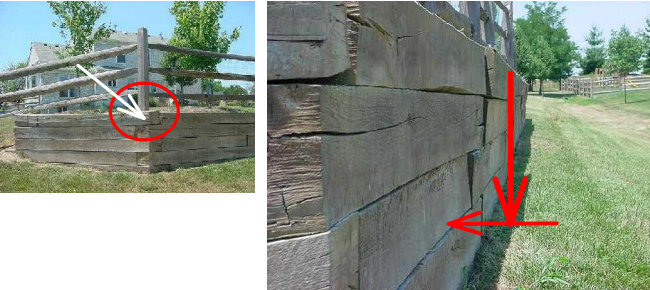
1. Vegetation: Shrubs with some weeds
2. Retaining Walls: Railroad ties The wall is showing signs of movement, but appears to be stable at this time. A qualified contractor is recommended to evaluate and estimate repairs to maintain the wall.

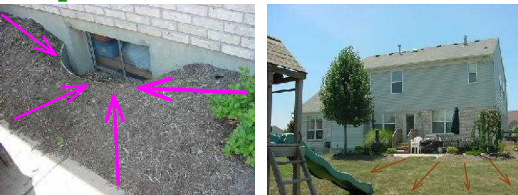
1. **Deck:** Treated wood The deck has been built below acceptable building standards and is not safe in its current state. Recommend further evaluation and estimate to bring deck up to an acceptable building standard.
2. **Grading:** Moderate slope The grade and landscaping materials are too high and extend above the window well at the Northeast rear of the home. Recommend that the grade be reduced or the metal window well soil retainer be replaced with a taller unit to keep the mulch and soil beds from washing into the well.

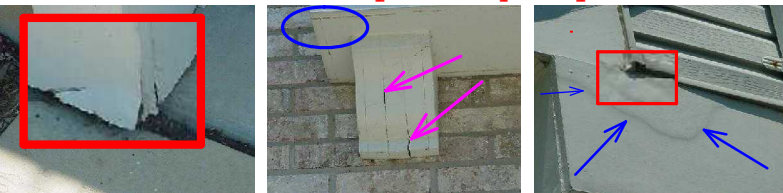
1. Water damage to trim wood at either side of garage door from moisture wicking into the finished particle board. The surface is starting to delaminate. Recommend repair/replacement of the trim boards and silicone seal wood that is in contact with concrete to prevent wicking.

2. The wood window boxes have water damage and will require repair/replacement. The wood has started to separate at the supports and at the corners of the window boxes.

3. The trim board at the southwest corner of the porch has water damage due to water penetration and will require repair/replacement of the wood. The trim board extends out creating a ledge allowing water to collect on the top edge of the board and cause the wood to rot.

Recommend estimate/repairs by a qualified contractor.
